CIA IMAGERY ANALYSIS DIVISION

NAME	COUNTRY	COORDINATES
Da Ben Highway Bridge Bridge No. 16 on NE 48-7	North Vietnam	18 25N - 105 48E WF 851362

BRIEF NO: PIB - 65006

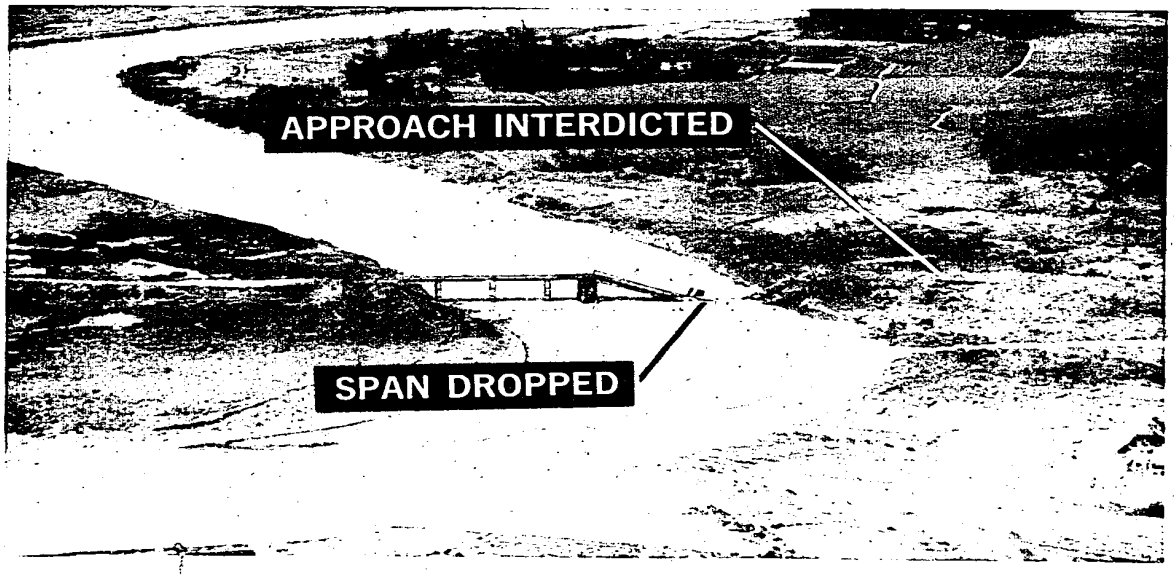
LENGTH	250'	MATERIAL	Steel and Concrete
WIDTH	12'	NO. OF SPANS	5
TYPE	Deck and Half-through Truss	LENGTH OF EACH SPAN	1-125, 3-35,1-20'

STATUS: Heavily damaged, 1 span dropped, approach interdicted

COMPENSATIVE ACTION: None
